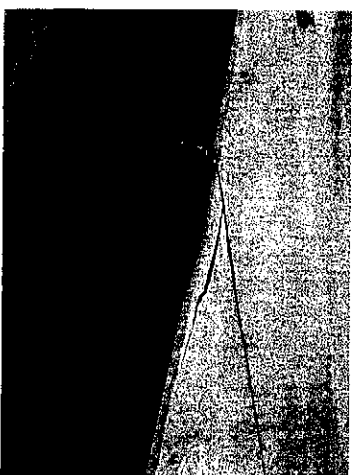
- There is spalled concrete at the west end of the south expansion joint in the slab. This should be repaired by removing the damaged concrete and filling the void with a cementitious patching material such as SikatoP Plus 122 by the Sika Corporation (S-28).
