NHDHR INVENTORY NUMBER: CON0221

453 Josiah Bartlett Road

The following information updates the inventory form prepared for 453 Josiah Bartlett Road in 1992, with a focus upon its agricultural history and outbuildings. The original form is on file at NHDHR.

INDIVIDUAL INVENTORY FORM

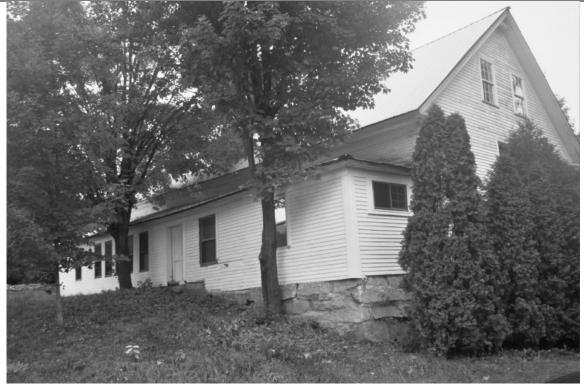
Roll: 3 Frame: 25 Direction: N

Photo 2 description: South corner of barn showing hipped roof cow shed addition

The 5 bay, 40'x60' queen post barn structure is a combination of hand hewn and circular sawn timbers with 2x6 roof rafters and horizontal roof sheathing. The third and forth level above ground grade ceiling was raised 18"-24" in the front two bays and used as a hen house. This area was screened off with chicken wire and whitewashed. It also appears that the southeast-facing windows on this level may have been enlarged to provide greater ventilation. Some of the interior elements of the milking parlor remain intact in the cow shed.

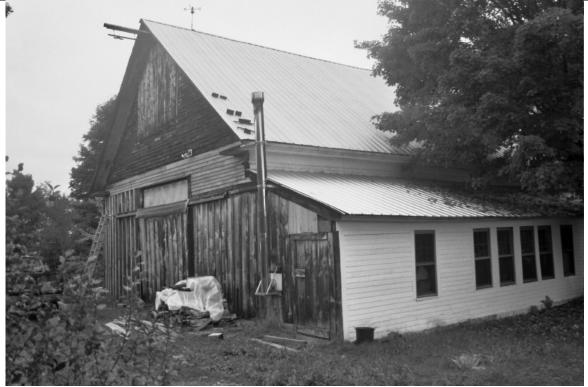
Roll: 3 Frame: 24 Direction: NE

Photo 3 description: Rear (northwest) and southwest elevations of barn and cow shed addition

Barn (ca. 1850-1870): Since 1992, this gable-front bank barn has had a new formed metal roof installed and the first story of the northwest side has been resided with vertical board and batten. Above the sliding barn door on the northwest side, the clapboards, horizontally hinged hay loft door and hay track remain intact (see photo #3). The transom over the barn door has been covered with translucent fiberglass. The front (southeast) and southwest sides of the barn remain unchanged from the 1992 survey.

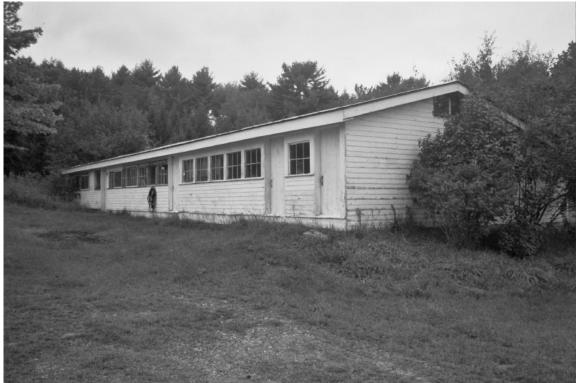
Roll: 3 Frame: 23 Direction: NW

Photo 4 description: One story hen house

One Story Hen House (1942): This 2x4 framed, concrete slab on grade, shallow pitched gable roofed structure retains its clapboard siding and corrigated metal roof and appears to be unchanged from the 1992 survey.

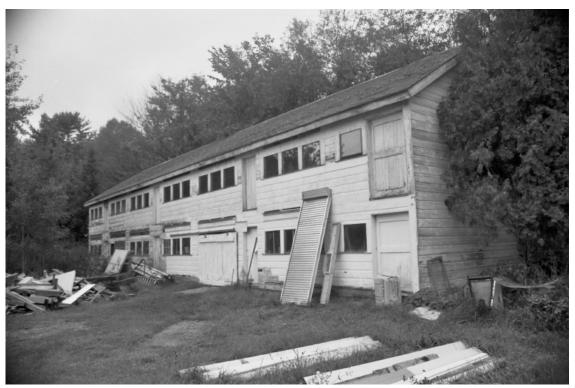
Roll: 3 Frame: 22 Direction: N

Photo 5 description: Two story barn/hen house

Two Story Barn/Hen House (1952): The novelty siding and asphalt shingle roof (southerly slope) remain intact as does the sliding barn door located on the front (southwest) side. A formed metal roof has been installed on the northerly slope of the gable roof. The structure is built on a concrete slab on grade with 2x dimensioned lumber. Physical evidence suggests, and Mr. Clemons confirmed, that the ground level of this structure appears to have been used for calving. Four pairs of passage doors are evenly placed along the southern face of the building on both levels, likely for ease of cleaning. Similarly, floor scupper openings are located at the level of the second floor to simplify cleaning of the hen house on that level. The structure is currently used for storage.
